Smoke and Dye-Water Observation Summary

Western Run Pilot Project - Baltimore Maryland

INSPECTION REPORT

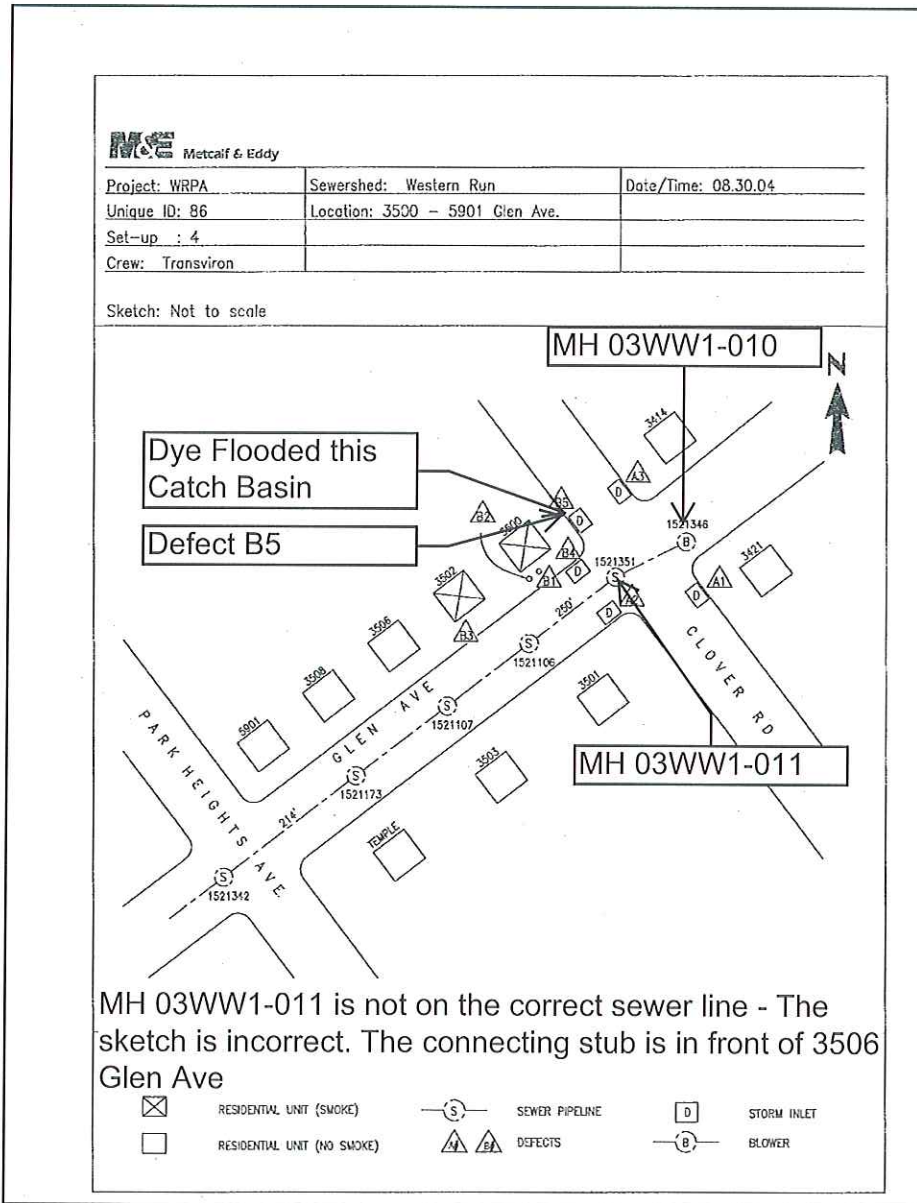
Sketch No: 86

Additional Comments: The Catch Basin never Flooded. Alot of the water leaked back into the _____
Main Storm line through breaks and holes.
